Aspects Regarding the Monitoring of Heritage Buildings

Mădălina Iordache, Ana Maria Grănescu and Cosmin Filip

The case studies analyzed are the results of research made in the Historical Center of Brăila Municipality, identifying an appreciable number of buildings, some historical monuments, others included in the historical center, having valuable elements for which a constructive attitude of conservation and restoration must be adopted.

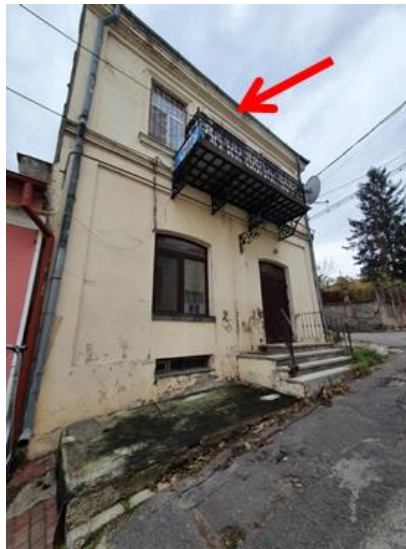
Fig. 1 Moisture due to the penetration of rainwater through degraded gutters

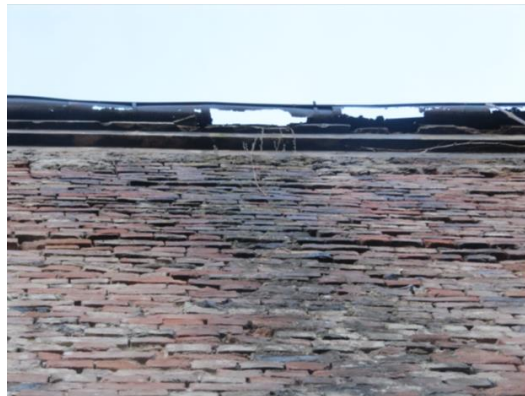
Fig. 2 Moisture due to the penetration of rainwater through degraded gutters

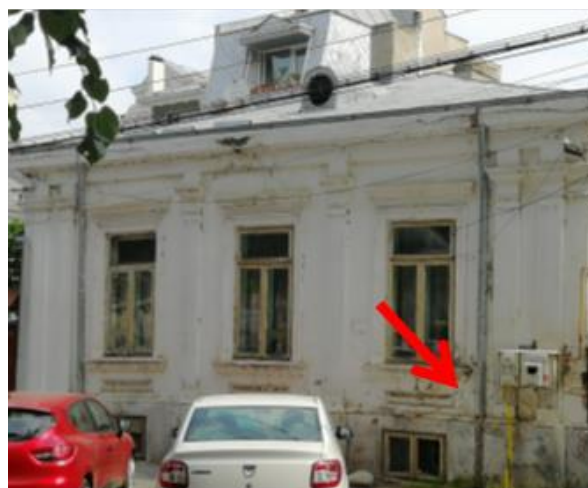
Fig. 3 38 B-dul Al.I.Cuza Street – Grinding effect of plaster due to moisture

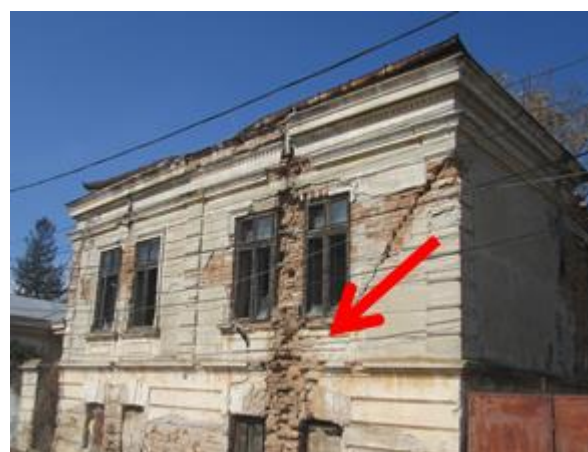
Fig. 4 10 Marăști Street – Degradation of the brick due to the phenomenon of repeated freeze-thaw of stagnant water on the surface of the wall

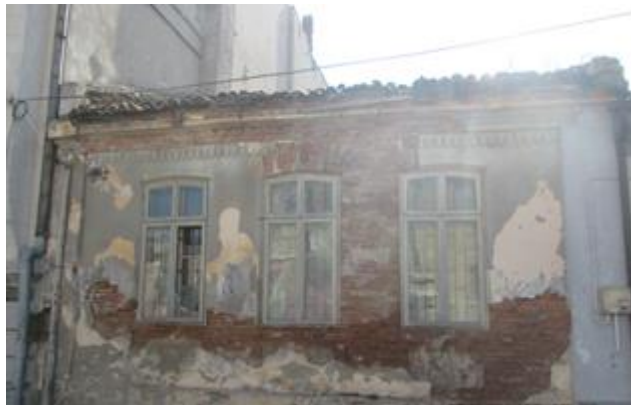
Fig. 5 6 Danube Street - Degradation of the brick due to the phenomenon of repeated freeze-thaw of stagnant water on the surface of the wall

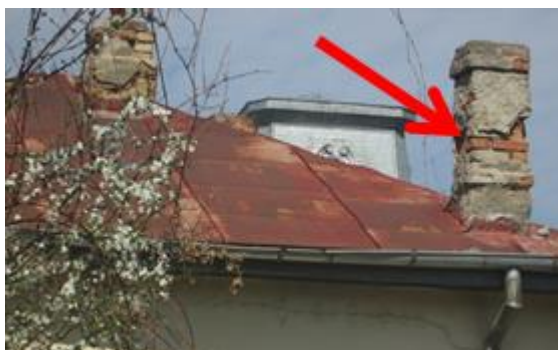
Fig. 14 11 Vapoarelor Street – Weakening of the chimney section

Of course, all these depreciations were also favoured by a series of degradations that appeared over time, such as: the lack of proper anchoring of the blind walls on the attic area or the lack of anchoring elements for the gables, or the weakening of the chimney sections due to smoke losses through the wet element (smoke becomes aggressive for masonry in the presence of moisture).

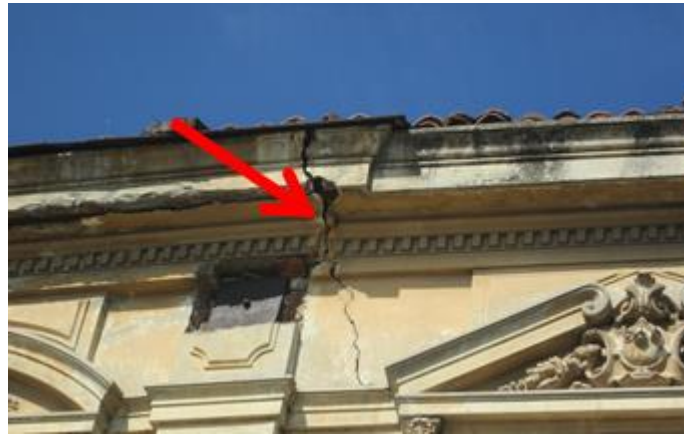
Fig. 15 7 Vapoarelor Street – Inclined crack extended over several asises

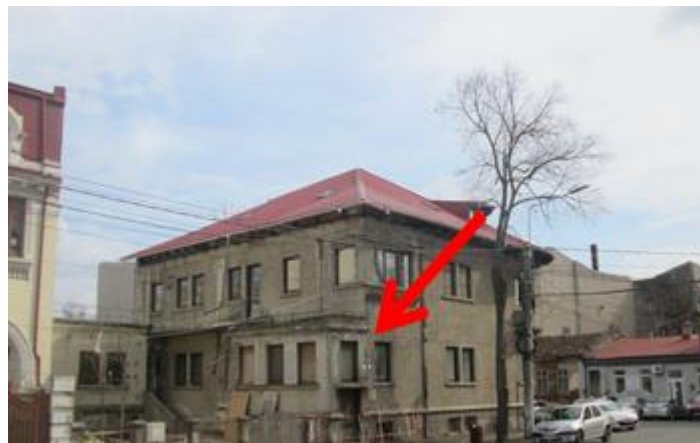
Fig. 16 9 Calea Călărașilor Street – Vertical separation crack

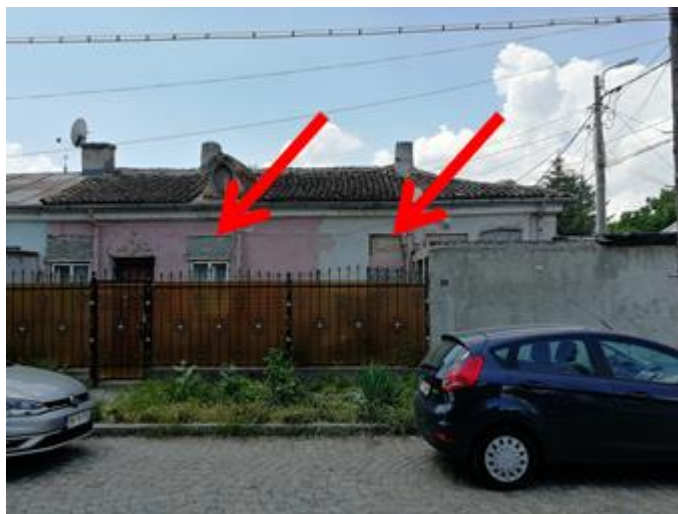
Fig. 17 11.Frumoasă Street – Interventions on historical constructions: modification of window openings by nonwoven masonry fillings

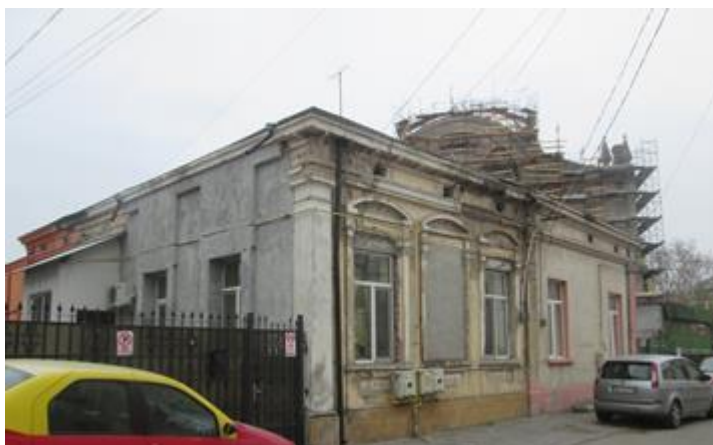
Fig. 18 9 Rubinelor Street – Interventions on historical buildings: modification of window openings by masonry fillings

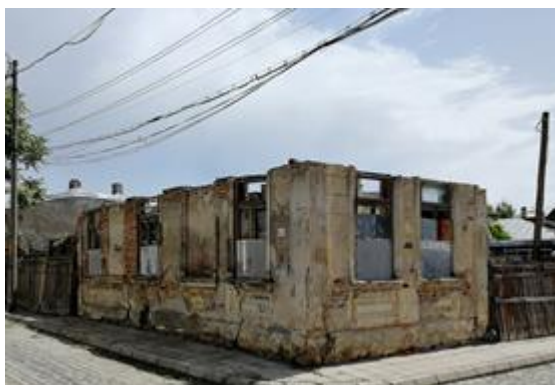
Fig. 19 11 Malului Street – Abandoned building

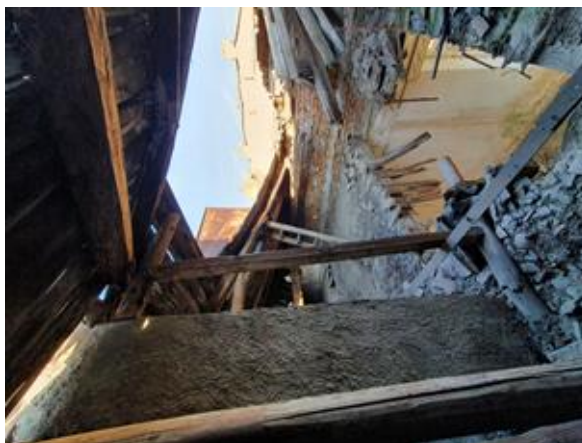
Fig. 20 Building on Mihai Eminescu Street – Collapsed floor
