# Poetry and Architectural Concept in Restoration of a Property in an Advanced State of Degradation in C. A. Rosetti Street no. 5 Brăila

Carmen Georgiana Țigău, Corina Elena Anghelescu, Bogdan Teodorescu and Ana Maria Grămescu

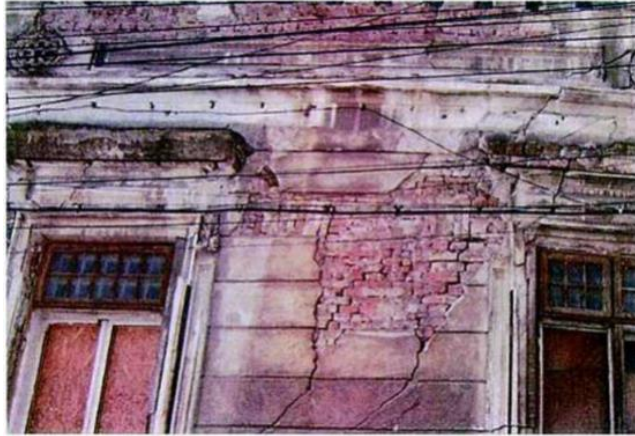
With serious and very serious damage, especially in the northern and eastern area of the C1 building due to infiltrations through the roof system led to the partial collapse of the building and the strong infiltrations over a long period led to the vertical deformation of the street facade so that at the current date, the two buildings are in poor physical condition, from the point of view of technical inspection and the conclusions from the technical expertise to the fundamental requirements of resistance and stability, consisting of structural precollapse and public danger of collapse, being non-functional. The C1 building is partially collapsed both towards the courtyard and towards the neighbourhoods and towards the street, with a high degree of vulnerability and imminent total collapse.

**Fig. 2** C1 Details - Façade from C.A. Rosetti Street

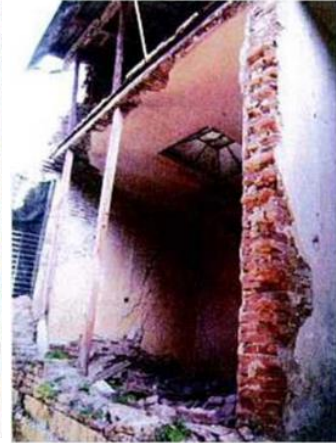
**Fig. 3** View of the back façade

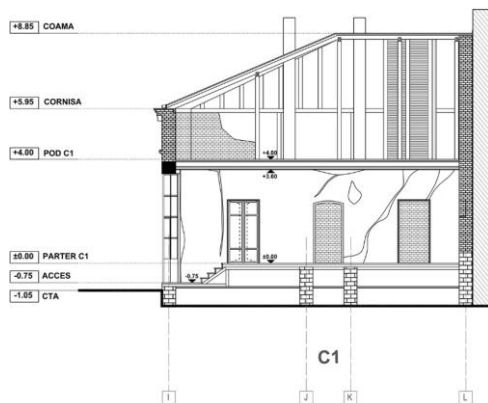
The C1 building is totally degraded, with collapsed areas and other areas of high risk of vulnerability. It is found that the main cause of the reduced resistances is the excessive infiltration of water produced over time, the seismic actions corroborated with an inhomogeneous structure of the load-bearing walls, doubled by the negligence in the administration and maintenance of the water-carrying networks both for the street area and for the neighbouring buildings as well as the building's own installations, as well as the existence of possibly collapsed historical underground tunnel that cross the property diagonally.

**Fig. 9** Survey of internal degradation

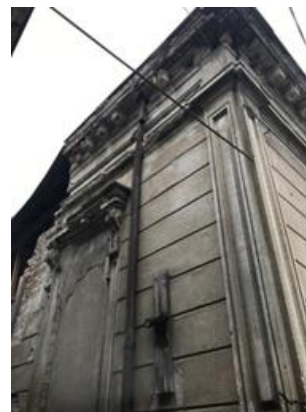
**Fig. 10** External degradation

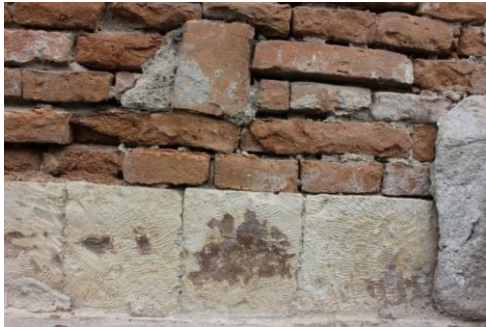
façade facing the street, the base made of stone masonry (calcareous sandstone from Dobrogea area), on the processed surfaces you can observe the traces of the processing with the garden (Figure 12), over which in another stage, was applied a brown paint. Later (probably in 1912, with the change of the owner), the restoration of the plasticity of the façade is carried out, and the base receives a plaster of imitation stone, processed in assizes and finished with a wide soffit. (Figure 13)

**Fig. 12** Traces of processing on garden façade

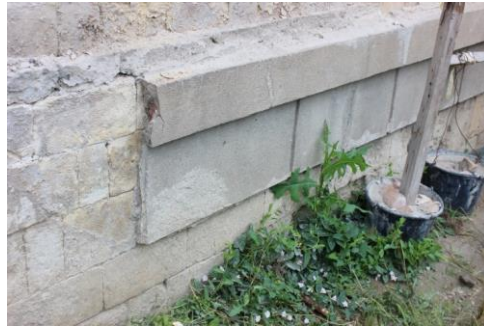
**Fig.13** Evolution of façade restoration through time

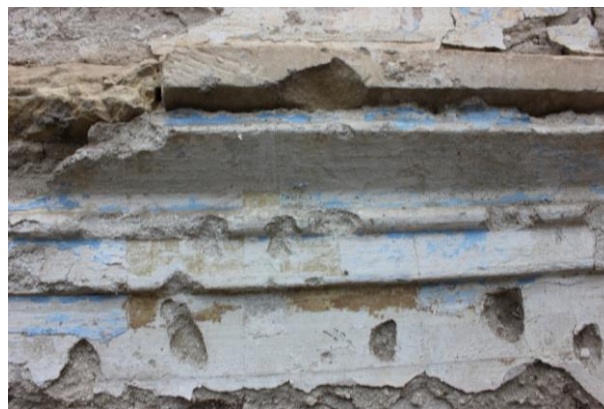
**Fig. 14**

The original façade of the building is made of plasters filled with lime and sand mortar (binder/aggregate ratio approx. 1/2 according to the Physical-Chemical Analysis Bulletin, by Dr. G. Niculescu). In the area of the excavation, there was found the existence of a simplified lime plaster decoration drawn with the template, finished at the top by a stone belt profile that marks the level of the window parapets. Both the field of full plaster and the decoration drawn with the template show traces of hammering, executed at the same time as the intervention to restore the architectural plasticity of the façades, probably in 1912. (Figure 14).

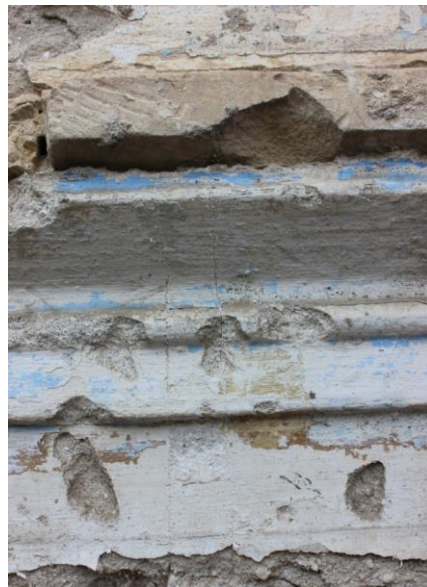
Observations: The stratigraphic survey on the south façade highlighted the layer of plaster and paint to mark the stone belt profile. In this way, two layers of color applied to the secco can be observed, in different stages: ochre and blue, the first being applied directly to the lime mortar.

**Fig. 15** Layers of the south façade

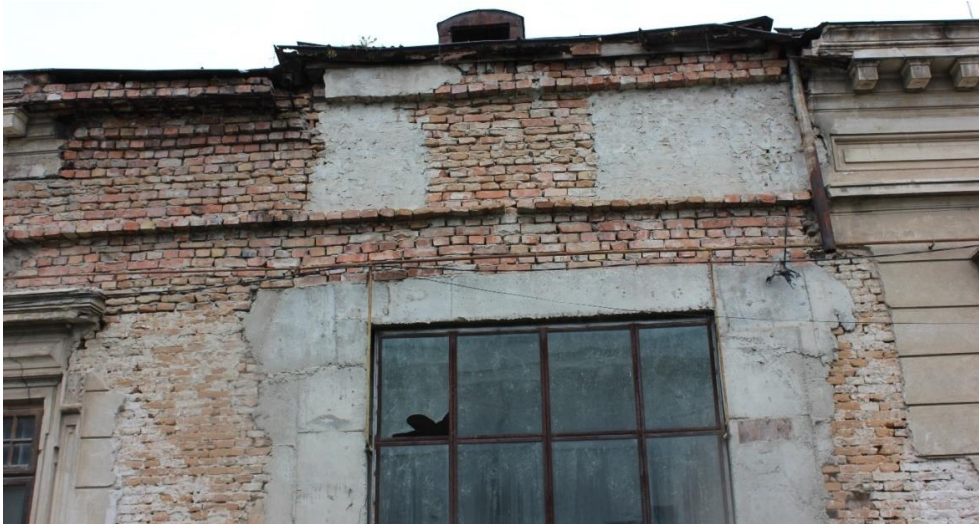
material on the upper part (starting with the cornice of the façade frame). The bricks used in the lower part have a format of 34 x 16.5 x 4.5cm, and the ones used in the upper part have the dimensions of 28 x 13.5 x 6.5cm. Moreover, it can be observed that the facing of the upper part has a single layer of plaster, from which also resulted the profiles drawn with the template.

**Fig. 16** The elevation stage in the evolution of the building – Entrance façade

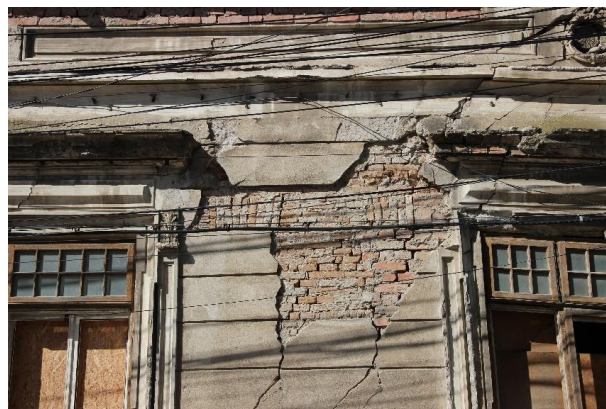
Thus, we can conclude that at the time of the restoration of the plasticity of the façades in the neoclassical style, the building was elevated, changing on this occasion the gaps to a certain extent (on the façade facing the street, one can observe the flattened arches of some gaps closed over time). As a construction technique, for the foundations there was used stone, the lower part of the elevation being made of masonry from stone piers (arranged in six asises), followed by an arrangement made of one and a half bricks, thus resulting in a thickness of approximately 55 cm for the external walls, the binder used being a lime and sand mortar, with a binder/aggregate ratio of approx. 1/2 - according to the Physical-Chemical Analysis Bulletin, by Dr. G. Niculescu.

**Fig. 17** The closure of the flattened arches – Street façade

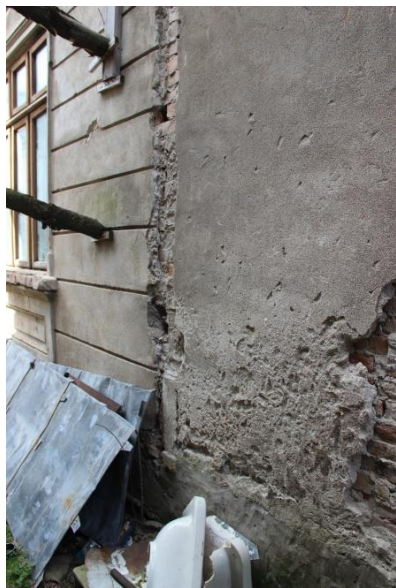
**Fig. 18** C2 Building

It is important to note that under the current facing of the façade of the construction C2 there are no traces of old plasters as in the case of the construction C1 (Figure 18), which leads us to consider two hypotheses regarding the building stages of the two constructions C1 and C2, starting from the premise mentioned above: 1) the construction C2 was built in 1875, a stage that also includes the restoration of the facades of the C1. At the same time, we must take into account the aspect according to which the construction C1, built between 1856-1867, shows, according to the stratigraphic survey, a sequence of interventions at the level of the façade (at least two) until the moment when the façade

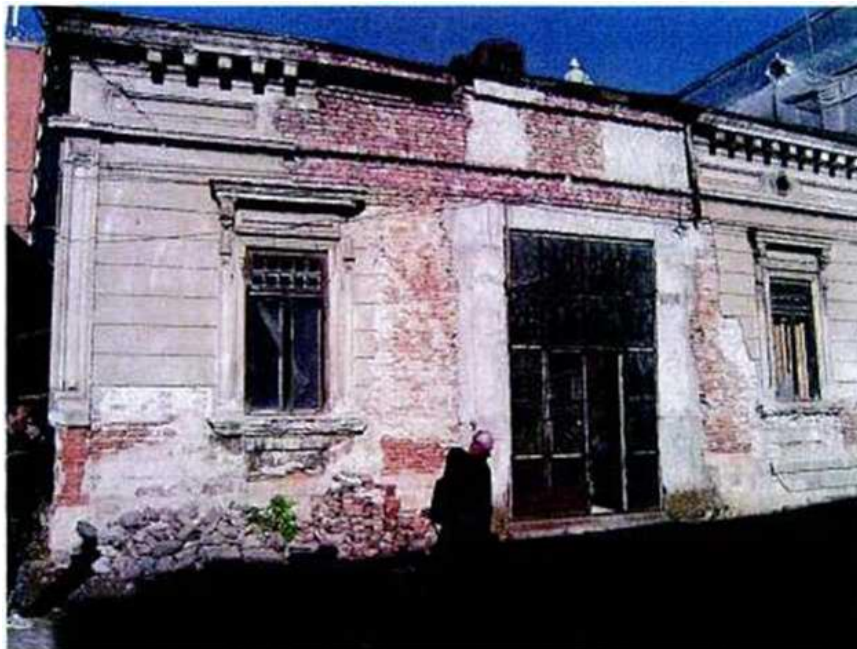
**Fig.19** The current Side façade with interventions made in time

The lost canopy above the original portal door, replaced by the current industrial-type metal structure, suggests the possible failure of some subsequent intervention of no value.
