Elements of Structural Reinforcement in Heritage Buildings

Ana Maria Grămescu, Mihaela Pericleanu, Corina Elena Anghelescu and Nicoleta Însurățelu

Keywords – *heritage buildings, metal anchors, restoration*

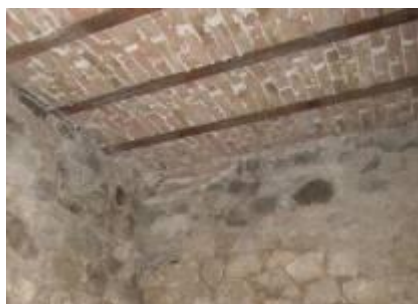
Fig. 1 Floor made of metal beams on which brick vaults discharge [7]

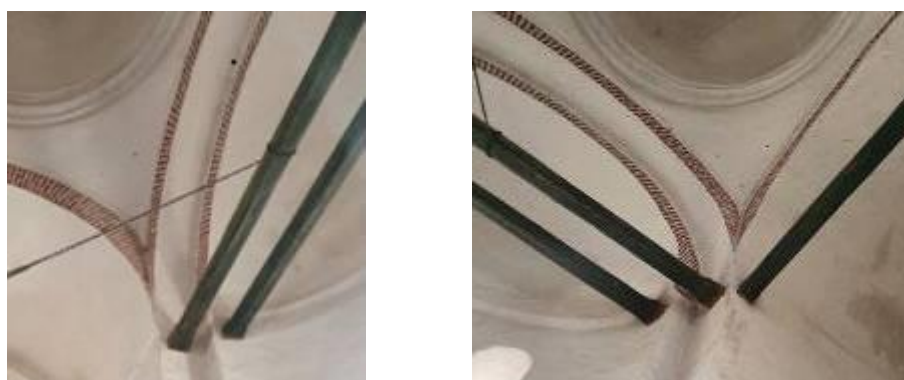
Fig. 2 Wooden truss - St. Nicholas Church, Bălteni Village, Periș, Ilfov County [7]

The anchor is the solution for embedding a tie rod in the form of a bar or plate that is usually required in tension. These elements have been used since ancient times, at first they were made of wood, and later of wrought iron. We find wooden ones at the church of Saint Nicholas, Bălteni village, built at the end of the 16th century Figure 2. [7].

In the case of wooden tie rods, if a humid environment persists inside the constructions, damage caused by biological attack may occur (wood degrades as a result of the action of fungal attack).

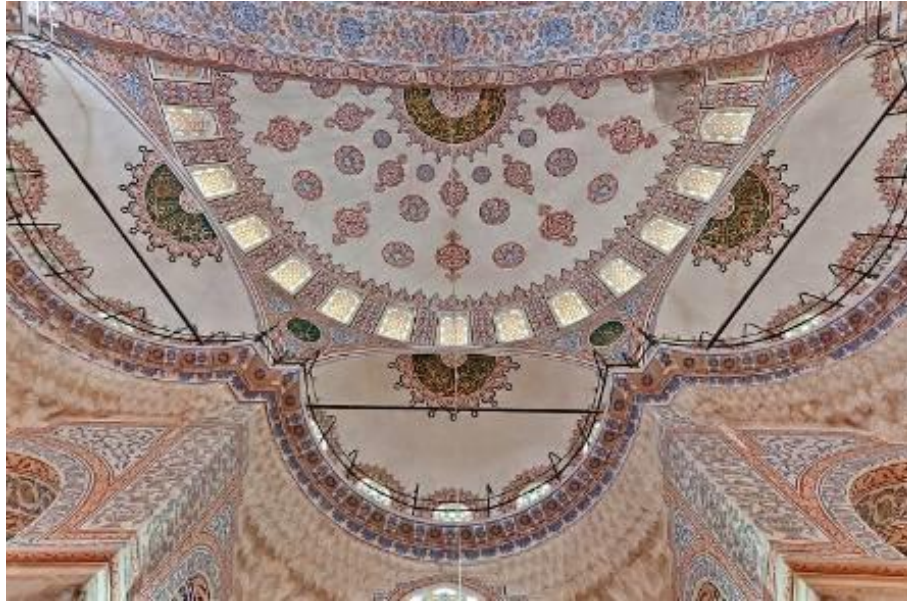
Fig. 3 Metal truss - Blue Mosque in Istanbul (17th century) [11]

Later, with the development of metal processing, metal tie rods in the form of bars or chains such as those in Figure 3, Figure 4 and Figure 5.

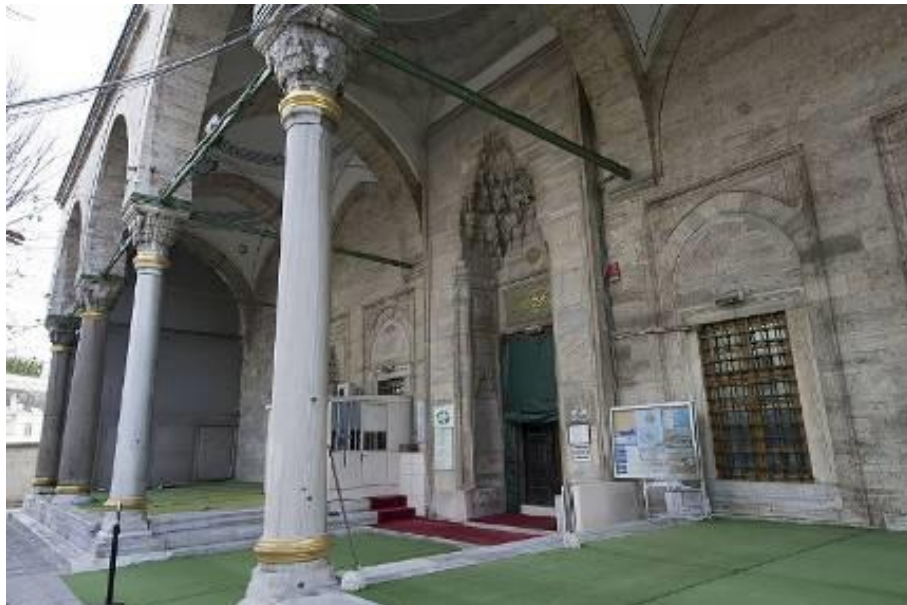
Fig. 4 Iron tie rods at the entrance of the Atik Ali Pasha Mosque Istanbul (15th century) [12]

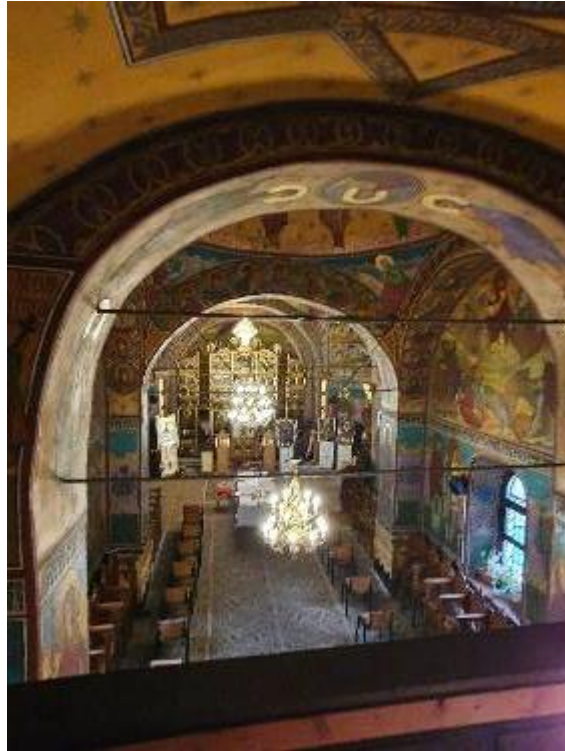
Fig. 5 Metal tie rod arch of the vault of St. Nicholas Church, Buzău County [7]

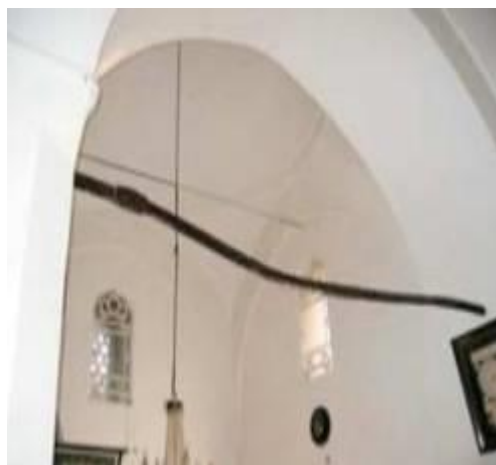
Fig. 6 Tie rod tension and interior of the Atik Ali Pasha Mosque in Istanbul (15th century) [1]

In the case of wrought iron tie rods, the most common form of damage is caused by their excessive corrosion. In the areas where the deterioration of the wrought iron tie rod is more intense, openings/discolorations of the material can be observed. Also distortions of the pretensioning devices, as a result of movements in the structure such as the examples in Figure 6 and Figure 7.

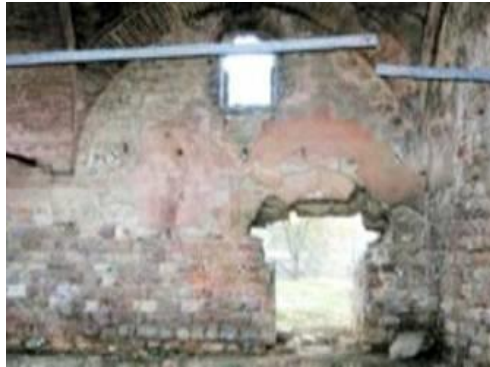
Fig. 7 Tie rod yielding in the central area, the Palace Edirne - kitchen building (15th century) [1]

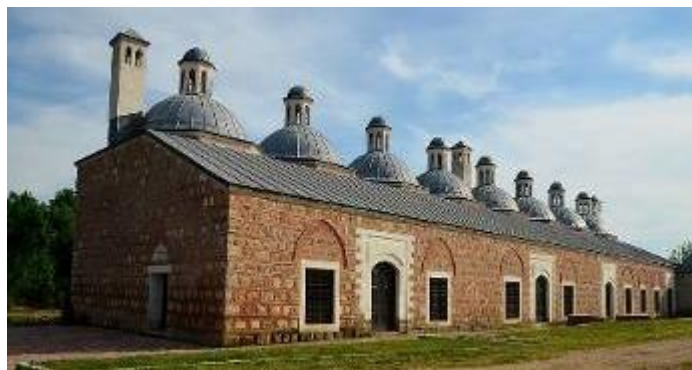
Fig. 8 Palace Edirne kitchen building (15th century) [4]

Due to its geometry, the kitchen building of the Edirne Palace in Figure 8 it does not have the same behaviour in operational loads and exceptional loads. During the earthquake, deformations occur in the vaults, at which point the tensile braces are required.

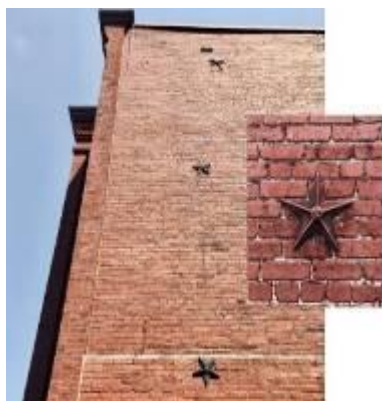
Fig. 9 Star anchor, the anchor plate in the shape of a star with 5 corners – Washington D.C. (U.S.A.) [18]

These star-shaped "bolts" are basically tie-rod end anchor plates or anchor systems to other strength elements. They are connected to a long threaded rod, and the rod is connected to existing beams, transverse walls, so basically to the structure of the house. Their role is to anchor structural walls to structural walls.

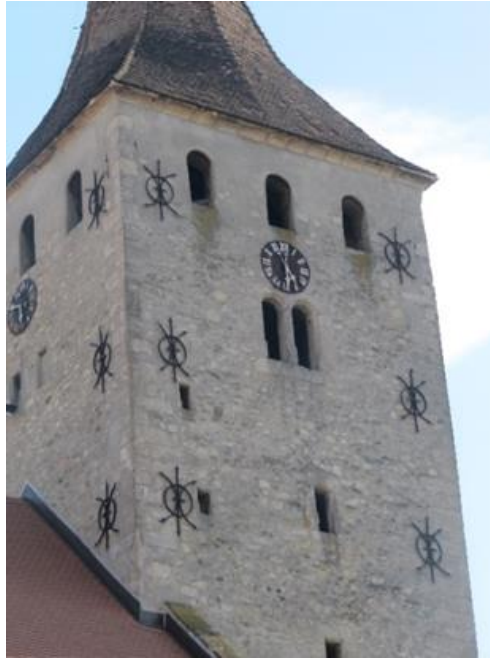
Fig. 10 The position of the tie rods with ornamental anchors at a historical tower, Alba Iulia City

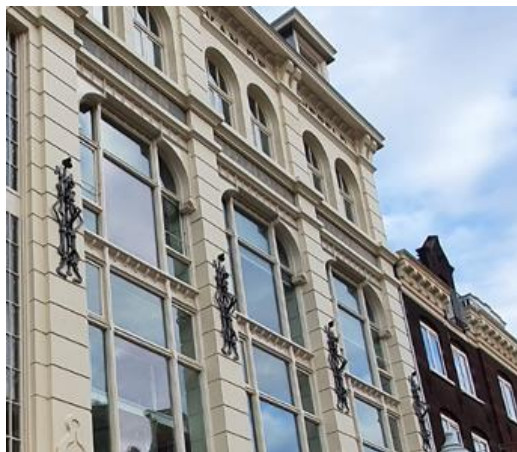
Fig. 12 Multi-storey building with metal anchoring elements next to the floors - Netherlands

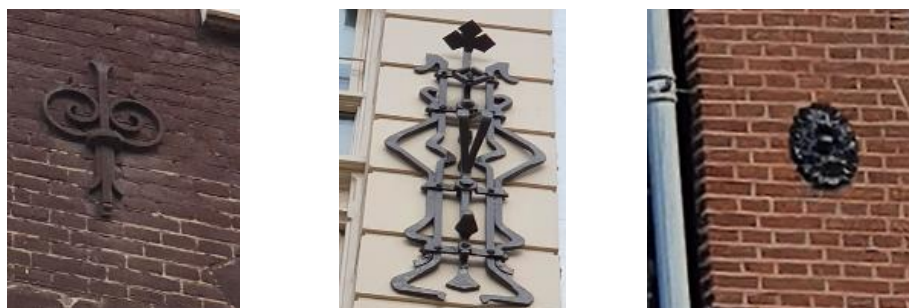
Fig. 13 Anchor types – detail

Sheave wall is most often made from a cast iron star or flat steel.

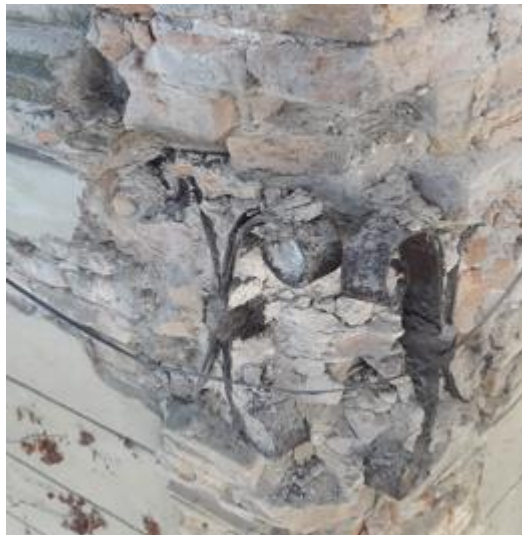
Fig. 15 Tie rod detail at the intersection of the exterior load-bearing walls of the facade

Corroded tie rods that no longer cooperate with the masonry. The effect of working walls at intersections is completely exhausted. The area had masonry expelled under its own weight. Area of intersection of load-bearing facade walls, floor 1 - intersection of Sulmona Street- Ovidiu Square, Constanța city.

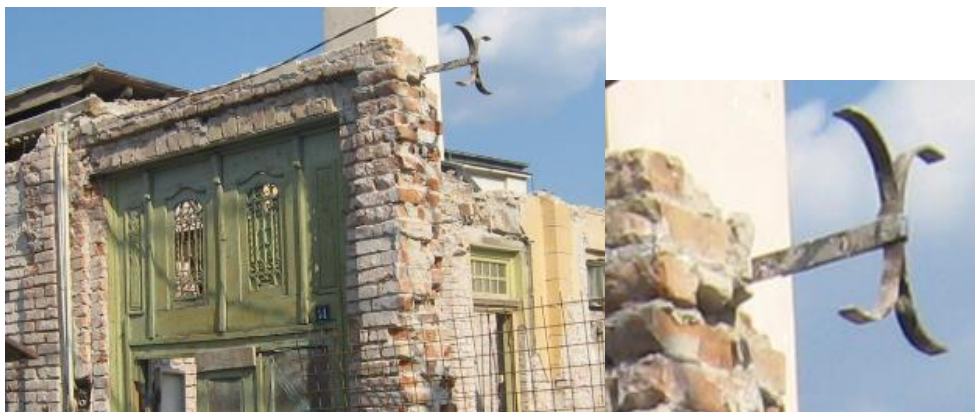
Fig. 16 A detail of tie rod with anchor highlighted in the situation of a building being demolished. Image of building built in the 2nd part of the 19th century in D. Bolintineanu Street, Brăila city

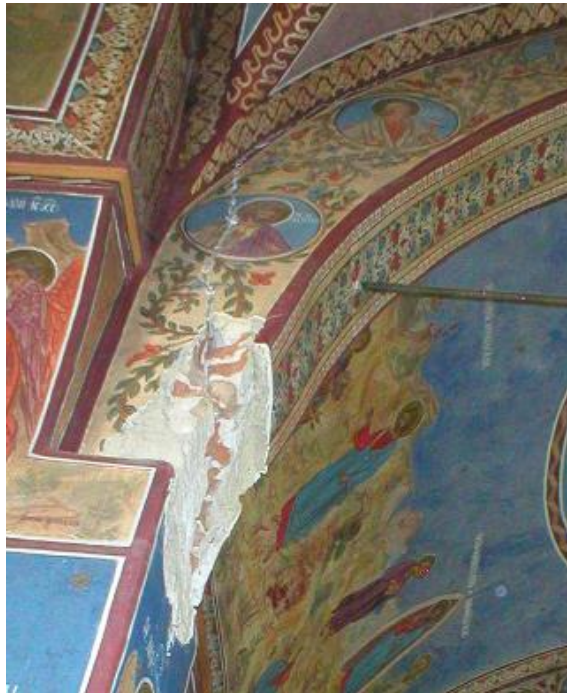
Fig. 17 The church of Nicolae Bălcescu village, Constanța County

When the anchorage length or the anchorage system is not, the flow level can affect the loss of stability of the anchored element. An eloquent example in this sense is the tie

rod of the Church in Nicolae Bălcescu village in Constanța County - you can see the yielding of the arch in the area of its birth.

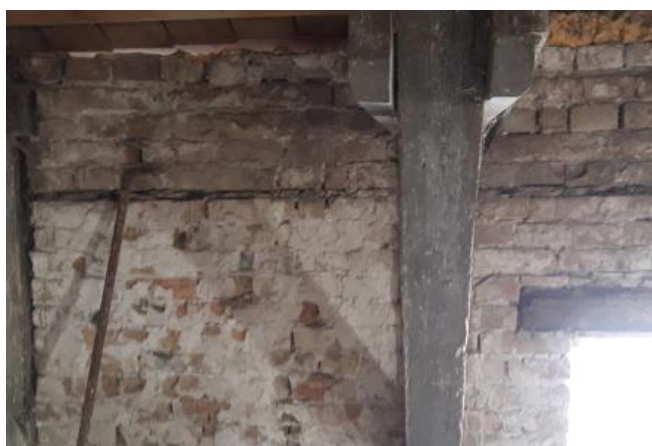
Fig. 18 Anchoring the pediment by means of an inclined plate. Building, Sulmona Street Constanța City

Apparent horizontal tie mounted next to the wall. The section is affected by corrosion.

Another application of these anchors is the connection and anchoring of the heels, of the gables of the existing frame. This solution is the most often used, but involves, in almost all cases, the strengthening of the existing framework, and sometimes also the strengthening of the masonry (for example by cladding).

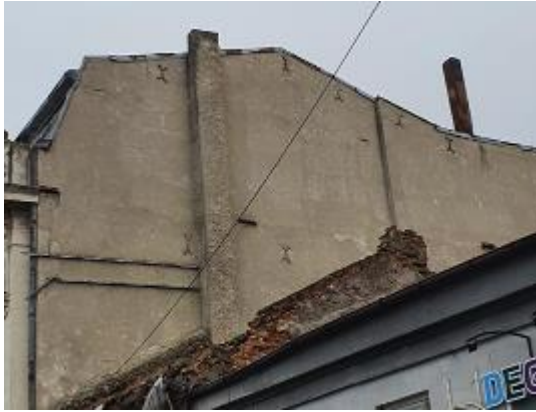
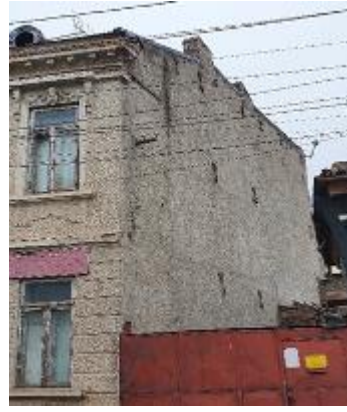
Fig. 19

Anchoring the side fenders by mounting tie rods between the wooden beams of the planks.
Buildings, Danubius Street, Brăila City

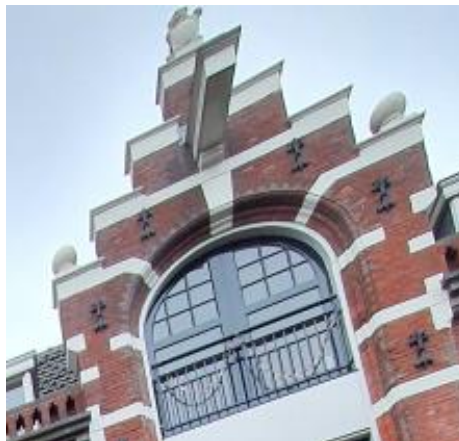
Fig. 21 Anchoring the gables, Holland

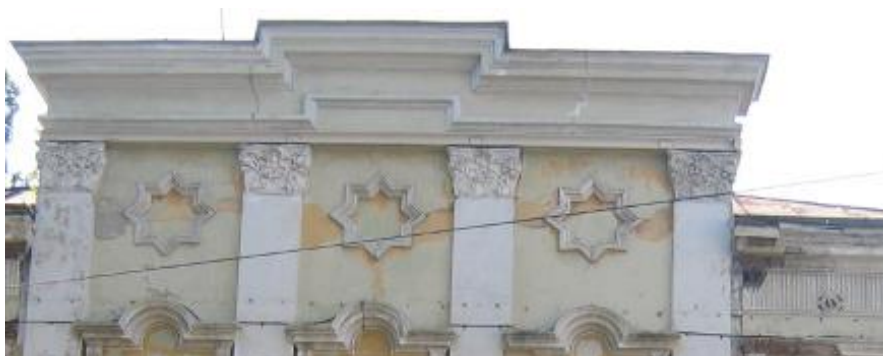
Fig. 22 Anchoring the pediment, at the level of the bridge, to the frame with the creation of ornaments in the shape of an eight-pointed star on the facade of a memorial house in Brăila

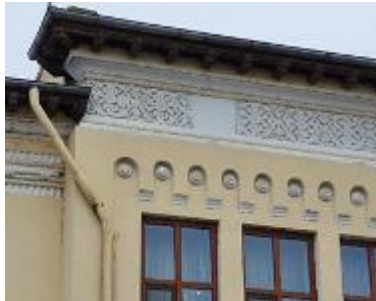
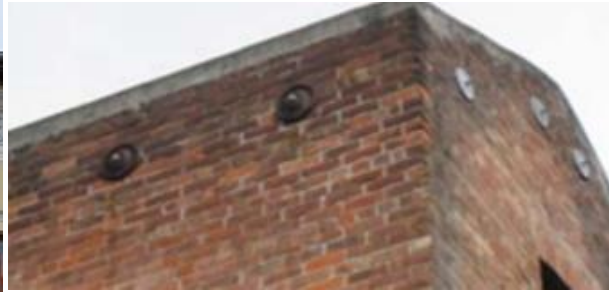
Fig. 23

Pediment anchors masked by circular ornaments arranged in the architecture of the facade

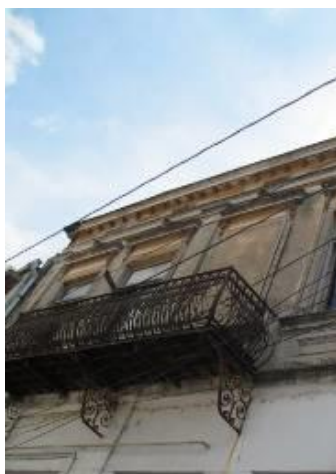
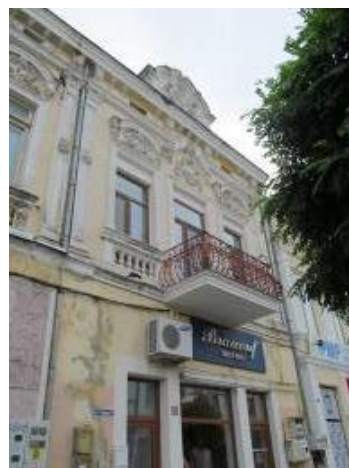
Fig. 28 Balcony of a private real estate

At the beginning of the 19th century, the balcony was a component that adorned and beautified any facade, being an element appreciated throughout Europe. Even the attitude of the authorities was beneficial for the use of iron, both for reasons of resistance, but also for reasons of protection against fire.

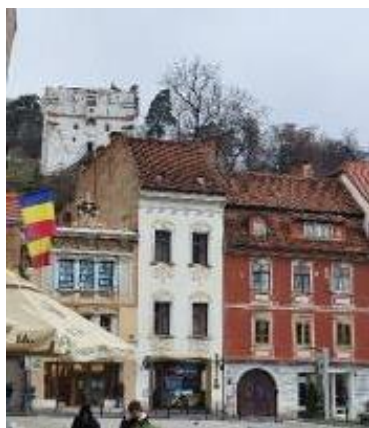
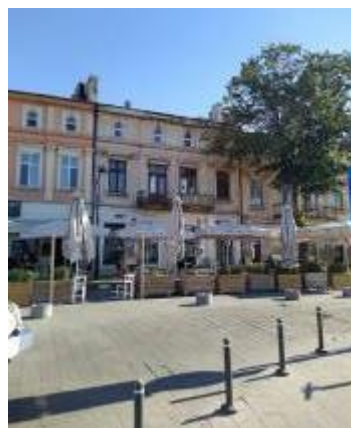
Fig. 30 Central image from Braşov City

Promoted in the second half of the 19th century, the architecture of the commercial street brings a substantial intake to the promotion of metal, as an element of resistance of the minor architecture and which manifests itself through the consoles of the awnings, wide shop windows, the local abandonment of the massive masonry enclosure and their replacement with a load-bearing metal structure, or even inside the commercial space, abandoning the load-bearing masonry and replacing it with metal pillars with beautifully ornamented brackets.

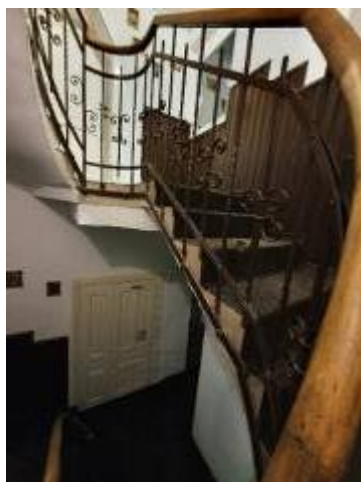
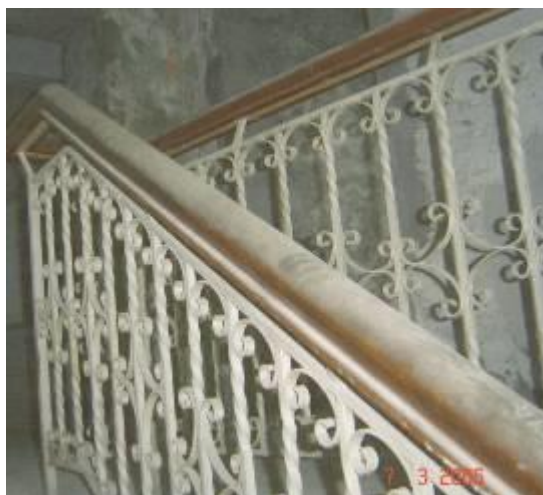
Fig. 32 The banister of the interior stairs

The balustrades of the balconies, as well as the balustrades of the internal stairs, become ornamental elements made by artists.
