## Methods for strengthening the ground and infrastructure of historical monument constructions

**Keywords** – consolidation, historical monument.

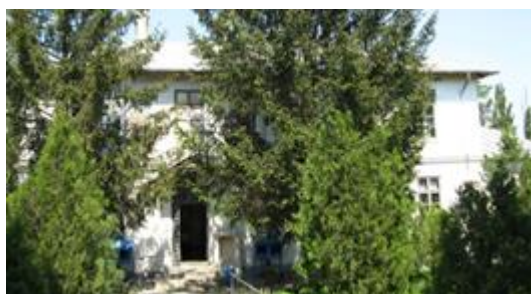
**Fig. 2** "Workshops" Building in the "Celic-Dere Monastery" Complex, Tulcea County,  
Source: Technical expert Prof. Dr. Eng. Ana Maria Grămesu in collaboration with  
Mădălina Iordache

The building is one of the two buildings constructed between 1910-1912 at the Celic-Dere Monastery, two-storey buildings that once housed the "Saint Anne" Church Painting School, a carpet, fabric, and sacred vestment workshop, as well as the Abbot's residence with a terrace

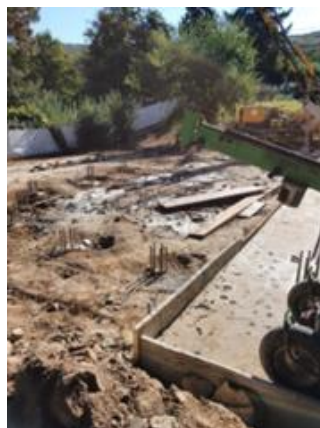
**Fig. 4** Micro-piles in the new altar area, lateral façade

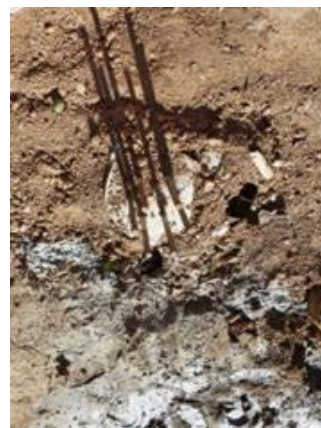
**Fig. 5** Detail of micro-piles

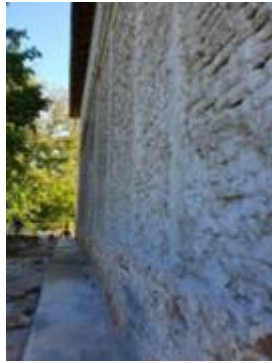
2. For the consolidation of the foundations of the workshop building, injections with a stable suspension of bentonite and cement were planned, abandoning the execution of a curtain of bored piles. [6]

The injection variant was adopted due to the fact that, after uncovering the foundations, it was found that they were made of river stone, which no longer had a binder, posing a risk that the structure of the stones could shift during the creation of the piles.

Therefore, injectors were placed in close proximity to the foundation, both inside and outside, creating a compact mass and rigidifying the building's foundation.

**Fig. 8** Area for injection with stable suspension of bentonite and cement  
Source: Mădălina Iordache

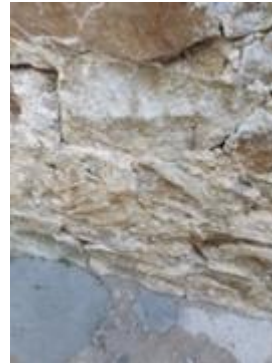
**Fig. 9** Injection with stable suspension of bentonite and cement  
Source: Technical expert Prof. Dr. Eng. Ana Maria Grănescu, Af. expert Dr. Eng. Cornel Ciurea

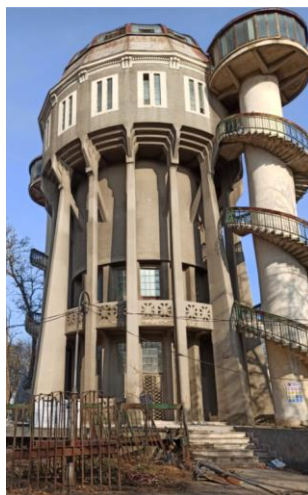
**Fig. 10** Main facade of the "Water Castle," Municipality of Brăila, Source: Mădălina Iordache

The tower had a height of 35 meters in 1912 when it was put into use and was considered the tallest water supply tower in Romania.

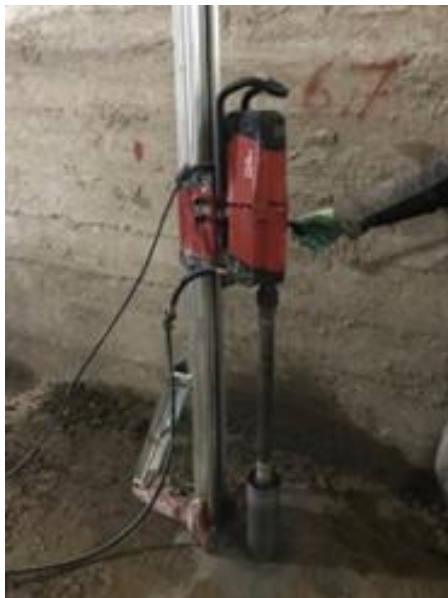
**Fig. 13** Penetrometer tests to verify the consolidation of the foundation soil after injection, Source: Mădălina Iordache

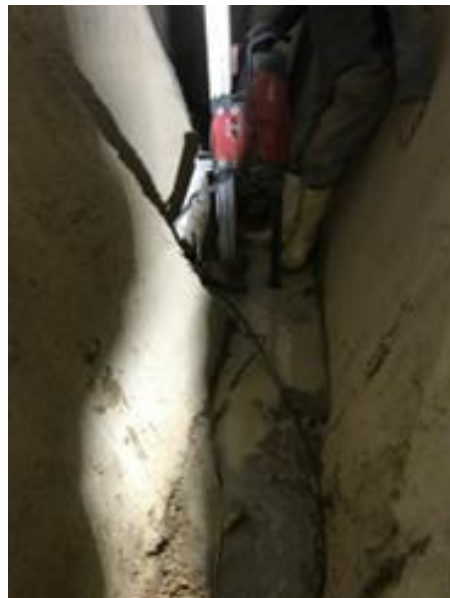
**Fig. 14** Penetrometer tests to verify the consolidation of the foundation soil after injection of the loess soil under the foundation slab, Source: Mădălina Iordache

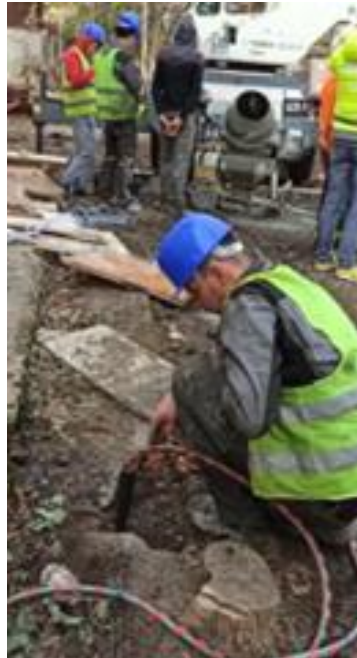
According to the resistance memo from the project "Rehabilitation of the Water Castle in the Public Garden, Brăila, 20 Public Garden Street, Municipality of Brăila," to create a vertical screen of injected soil around the foundation slab, injection through sleeve tubes was used, and the injection process was "ascending."

Drilling for the introduction of sleeve tubes with a diameter of Ø80-100 mm was performed inclined, oriented inward, to a depth of 13.00 m.

Soil injection was carried out with a cement-based solution with the addition of bentonite, forming a stable, self-hardening suspension. [9]

**Fig. 15** Injection through sleeve tubes of the soil, Source: Mădălina Iordache
