# Poetry and Architectural Concept in Restoration of a Property in an Advanced State of Degradation in C. A. Rosetti Street no. 5 Brăila

Carmen Georgiana Țigău, Corina Elena Anghelescu, Bogdan Teodorescu and Ana Maria Grămescu

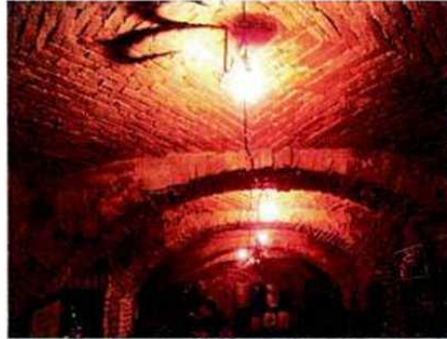
**Fig. 6** Underground tunnel / cellar, C. A. Rosetti street no. 3

Right next to the researched building, basements were identified belonging to a previous stage over which buildings were built at the beginning of the XXth century.
