### Valuation of historical buildings

Abstract – The present work brings together various intervention solutions on similar buildings in the city of Oradea, dating from the same period: around the 1900s. The buildings of the study are not historical monument buildings, but in the General Urban Plan of the city of Oradea, they are symbolized as buildings of historical value. The structural system of the buildings is similar, as well as their shape. The constructions had various initial functions and the interventions on them are carried out in order to change the use, also in order to bring them to the current exploitation and performance norms. Consequently, the work presents various ways of approaching these constructions from an architectural and structural point of view, giving solutions for their value recovery. Depending on the proposed function, the interventions are carried out respecting the architecture of the buildings as well as their valuable elements, which demonstrates a correct attitude of the actors involved for the transmission of valuable architectural and structural qualities to future generations. At the same time, the work proves that there are solutions in th

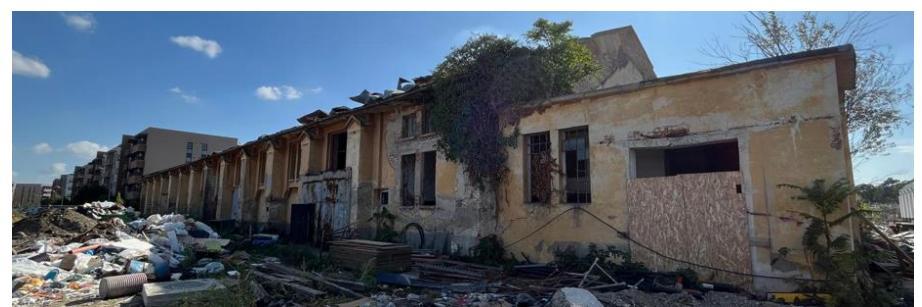
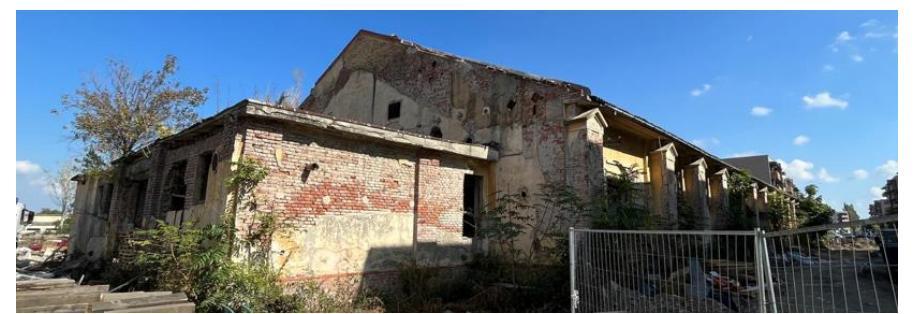
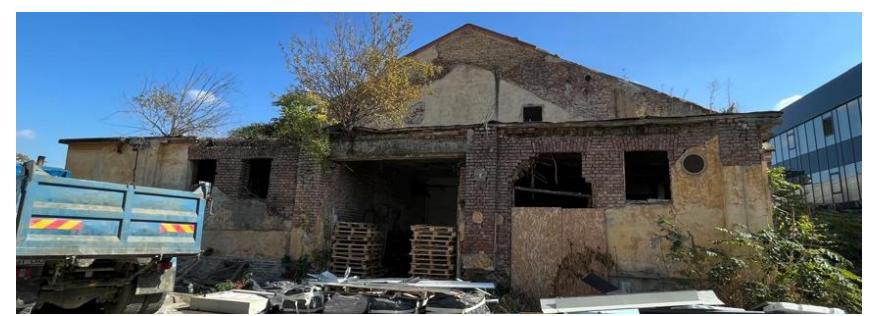
Fig. 5 Building F – North facade 07.2024 [4]

Fig. 6 Building F – Sud-West facade [4]

**Fig. 7.** Building F – West facade [4]

The state of decay of these buildings is advanced due to their lack of exploitation, except for Building A (Fig. 5-12).

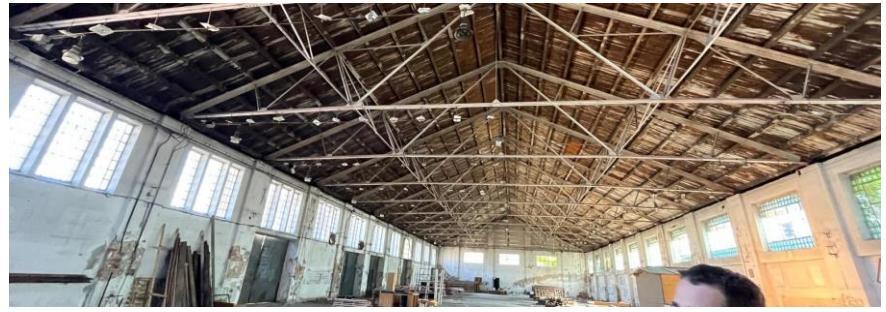
Fig. 8 Building F - roof structure - metal truss [4]

The masonry is made of old, unreinforced brick; the thickness of the walls at the main body is 60 cm. They are reinforced with masonry pilasters / buttresses. The opening of the main body is large, varying from one building to another between 23 and 30 m, being covered with a metal truss / beams with triangular lattices, placed at interaxial distances of approx. 5.00 m. Their particularity is that the nodes of the trusses are riveted through gussets and platbands, joints that are no longer practiced today (Fig. 8).

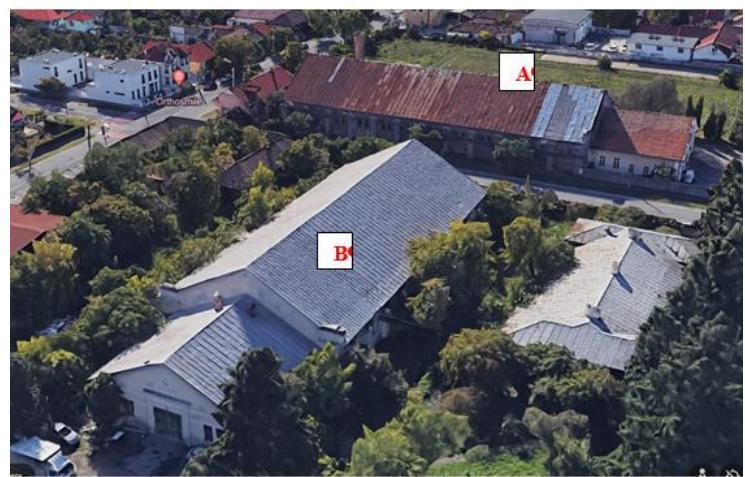
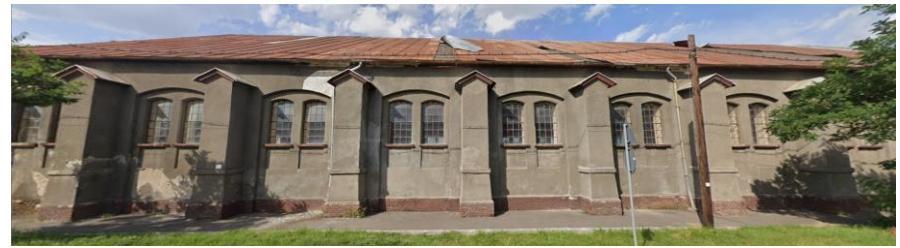
Fig. 9 Building A – East facade 10.07.2022 [5]

**Fig. 10** Building A – East facade [4]

Building A (Fig. 9-11) – due to some extreme phenomena, the sports hall was uncovered, thus, in the studied phase, the interventions are minor; only to replace the covering with sheet metal of the same weight / sqm:

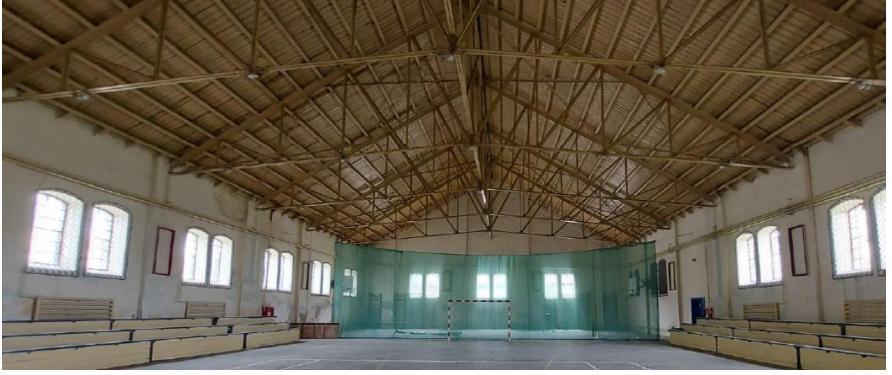
Fig. 11 Building A – roof structure - metal truss [4]

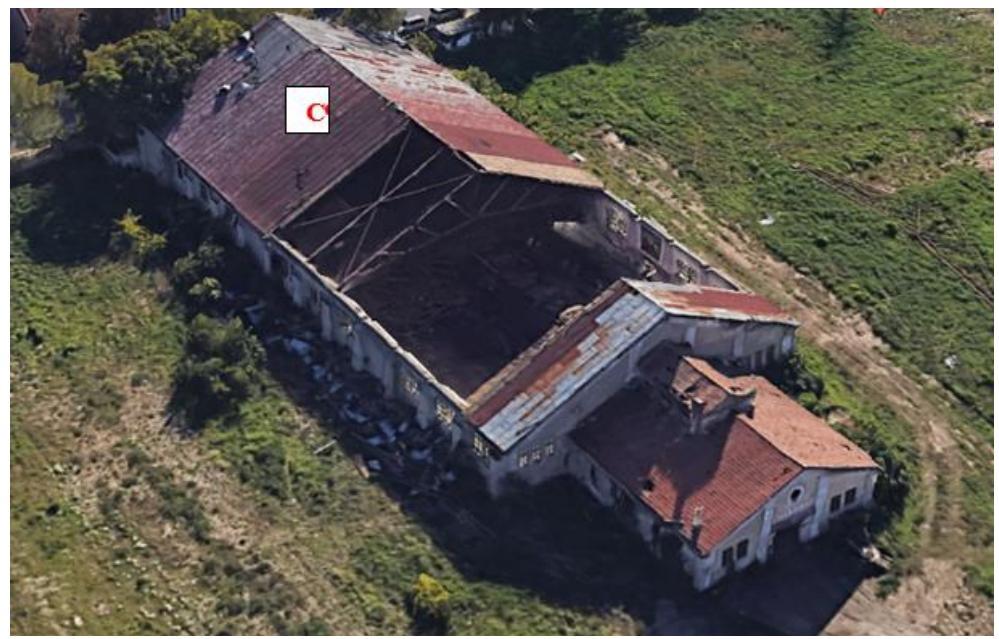
Fig. 12 Building C – North-East facade 10.07.2022 [5]

Building C (Fig. 12-13 - it is necessary to demolish it, to serve the public interest, for the construction of the new hospital for infectious diseases in Oradea. Considering that this body is a representative building, with special patrimonial values, proposed for local protection, the justification for the need to demolish this building was imposed. One of the arguments was that in Oradea there are buildings with a similar structure, of the same value as this one, which become witness buildings (buildings A and B):

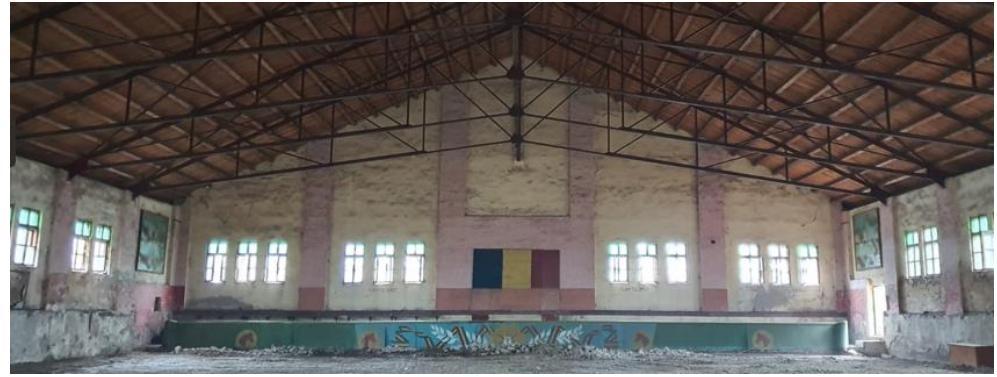
Fig. 13 Building C – metal trusses 05.2021 [6]

same time educational material for the students architects and builders of the University of Oradea respectively of the Faculty of Construction, Cadastre and Architecture in Oradea. This condition was imposed due to the existing metal trusses, having a very large span or a span of 30 m and having riveted nodes. The solution validated by the authorities, which meets this condition, is highlighted in figure no. 14:

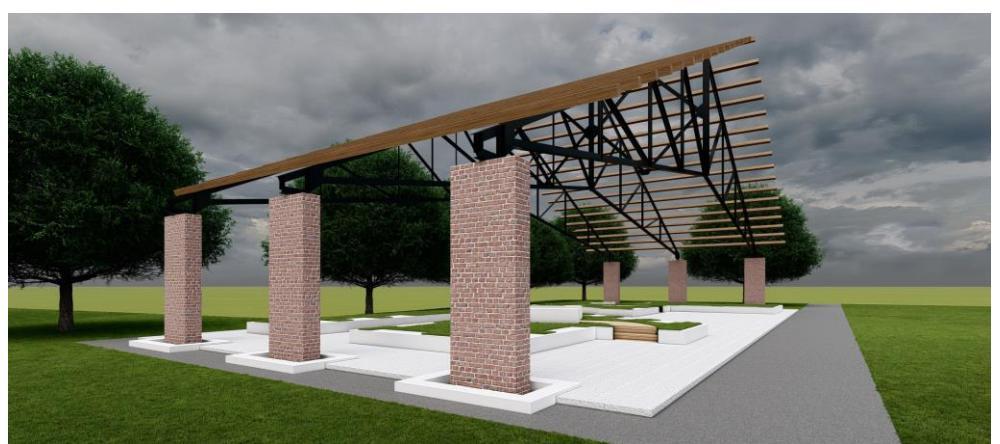
Fig. 14 Testimony of building C – metal truss [7] Project in progress

Considering the public interest of the proposed investment on this site, the Zonal Commission of Historical Monuments gave its approval for the demolition with conditions: 2 beams of this hall will be transferred to the Campus of the University of Oradea, so that this transfer will provide solutions for rehabilitation and conservation of three metal trusses with riveted nodes: these will become testimonies of the demolished building and at the

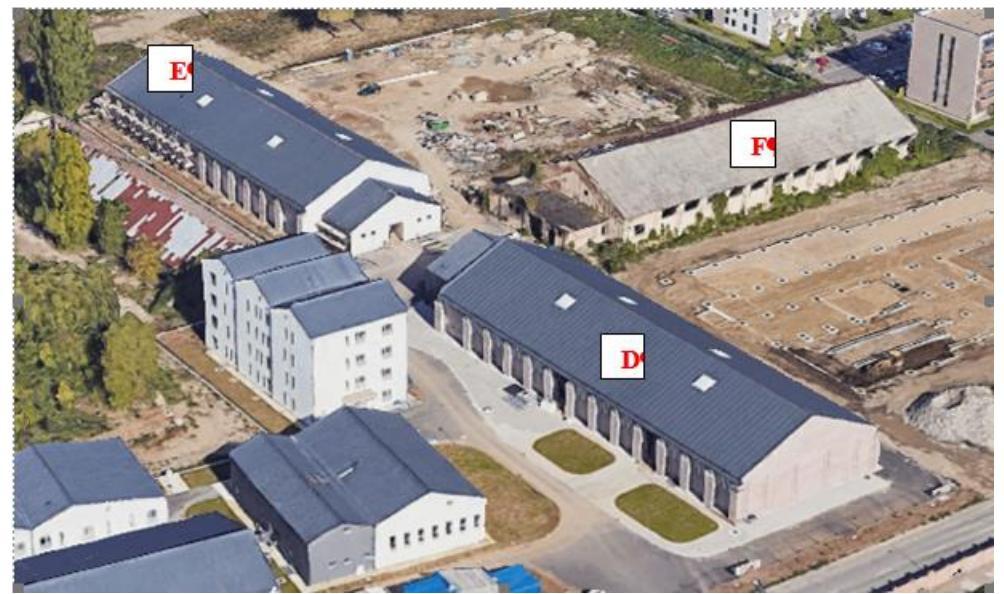
**Fig. 15** Buildings D, E F 07.2024 [5] Buildings D and E after the intervention of rehabilitation, consolidation, arrangement

Buildings D and E had the same interventions, within the same project: Consortium for Dual Education Campus Oradea. As part of this project, Building D was consolidated, rehabilitated for energy efficiency, respectively it was designed to correspond to the function of a Workshop. Building E has been rehabilitated and energy efficient, respectively it has been fitted out to correspond to the function of a gym. A consolidation, rehabilitation and energy efficiency project are being developed for building F to have the function of a warehouse.

The interventions on them are consolidation, casing, interior equipment with energyefficient installations, provision of electrical energy production equipment on envelopes (photovoltaic panels) and arrangement of interior spaces to correspond to the proposed functions.

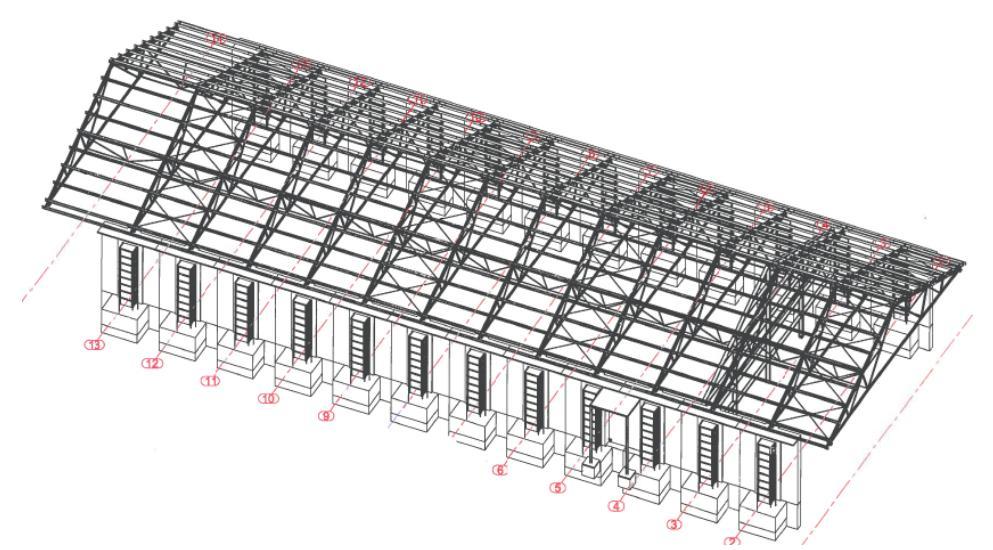
Fig. 16 Proposed intervention to strengthen the pilasters Confinement solution with metal profiles [9]

We highlight in the present study the interventions proposed / carried out for the consolidation of the structures, with the interest of maintaining the historical metal trusses, as well as the masonry with old brick pilasters (Fig. 16, 17, 18):

Good understanding by the authorities of the value of historical buildings leads to their valuation. Thus, from the package of the three similar buildings D, E, F, located on the same site, it was decided to treat building F as a historical monument building, at the same time assigning it the function of a warehouse, thus renouncing its envelope and opting for the consolidation solution highlighted in Fig. 16. In this way, the original volume of the building is maintained.

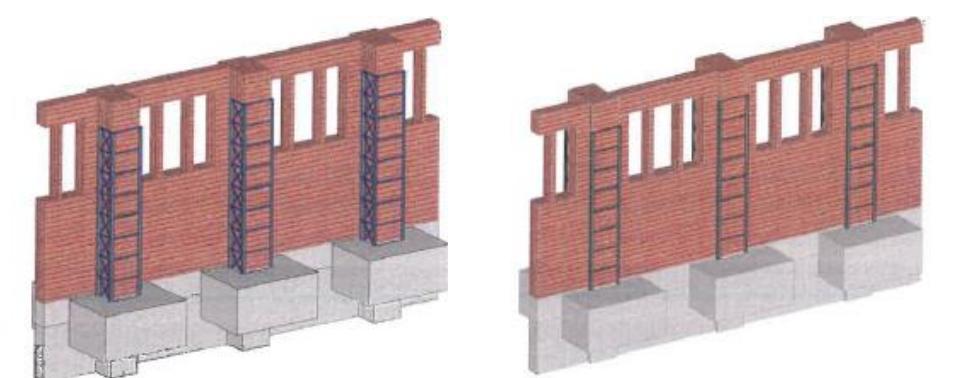
Fig. 17 Proposed intervention to strengthen the pilasters Outside View and Inside View [9]

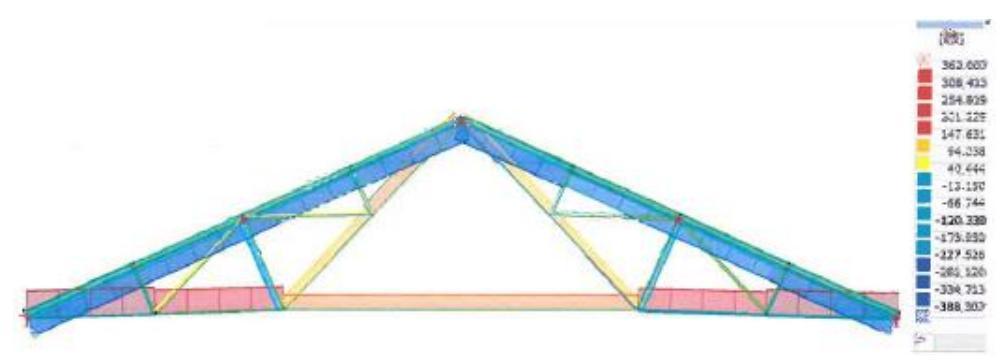
Fig. 18 Buildings D, E. Lattice farm. Axial stress diagram - consolidated situation [9]

The reinforcement of the metal truss was made by doubling the upper sole with a rectangular profile, attached only to the truss nodes. The metal panels (Z profiles) and the bracing system were attached to it.

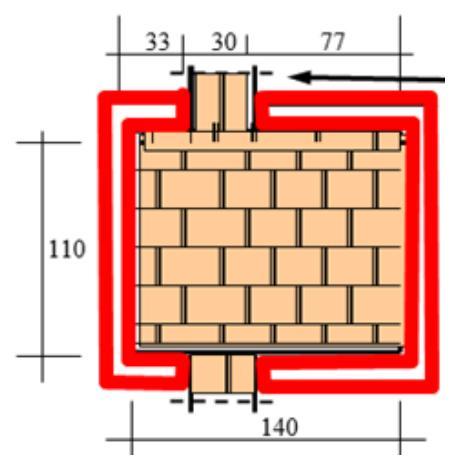
With the implementation of the project, the solution for strengthening the pilasters was changed, so that they were lined/plastered with reinforced concrete, according to Fig. 19.

Fig. 19 Section through the pilaster – reinforcement solution by lining [4]

These consolidation and rehabilitation solutions: lining the pilasters and thermal wrapping of the building, changed the proportions of the original building, the result of these interventions being highlighted in Fig. 14. The interventions on the volumetry of buildings D and E can be considered slightly aggressive.
